**Flood Control Project Maintenance
Levee Inspections**

Fall 2012 Levee Maintenance Deficiency Summary Report

Reclamation District No. 0554 Walnut Grove

Waterway					Bank	Unit Miles	Inspection Start/End	Inspector
Unit No. 01 Sacramento River					Left	1.09	10/04/2012 10/04/2012	Herman Phillips

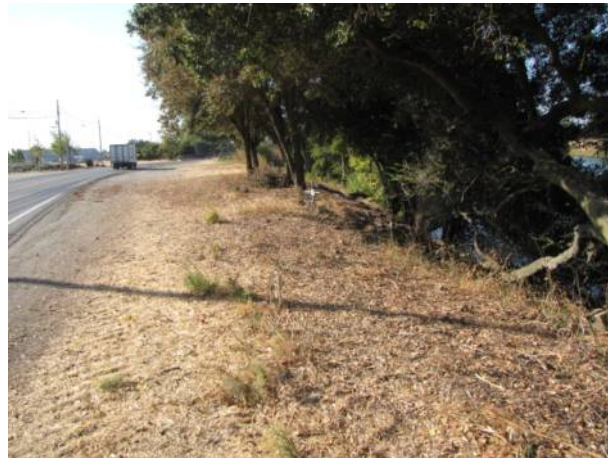
Levee Mile Report Line	4
Start Levee Mile	0.07
End Levee Mile	0.07
Location	Water Side
Category	Earthen Levee
Item	Vegetation

RD 554 looking downstream from levee mile 0.07 waterside shoulder. Photo taken 10-04-2012.

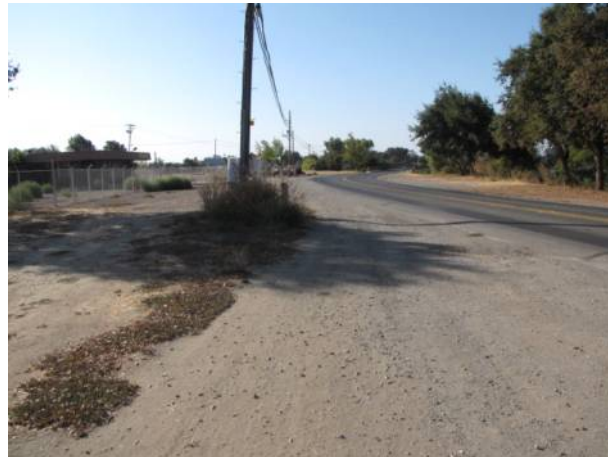
Levee Mile Report Line	5
Start Levee Mile	0.07
End Levee Mile	0.07
Location	Land Side
Category	Earthen Levee
Item	Vegetation

Looking downstream from levee mile 0.07 RD 554. Photo taken 10-04-2012.

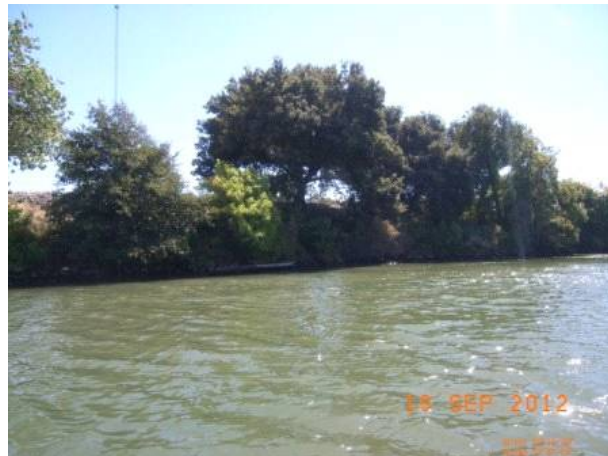
Levee Mile Report Line	7
Start Levee Mile	0.25
End Levee Mile	0.34
Location	Water Side
Category	Supplemental
Item	USACE Erosion Survey

DWR ID: DWR_RD0554_01_f_2012_5									
7	0.25	0.34	Supplemental	USACE Erosion Survey	WS M Ma	Inspector Comments: 2009 - Tension cracks on road on top of levee. Erosion into the levee slope and mass failure. 2012: No observed change. [2012 Site ID: SAC_27-0_L]	38.246222 ° -121.510878 °	38.245017 ° -121.511740 °	2 Y
DWR ID:									
8	0.32	0.32	Earthen Levee	Encroachments	WS M Ma	TR : Tree or limb	38.245152 ° -121.511435 °	38.245152 ° -121.511435 °	7
DWR ID: DWR_RD0554_01_f_2012_7									
9	0.34	0.34	Earthen Levee	Encroachments	WS C En	TR : Tree or limb	38.244942 ° -121.511544 °	38.244942 ° -121.511544 °	1
DWR ID: DWR_RD0554_01_s_2012_1									
10	0.63	0.80	Earthen Levee	Vegetation	WSA/W Ob	V8 : Environmental Requirements.	38.241503 ° -121.514579 °	38.239527 ° -121.516441 °	4
DWR ID: DWR_RD0554_01_s_2012_4									
11	0.97	0.97	Earthen Levee	Encroachments	WS M En	BU : Building	38.237108 ° -121.516743 °	38.237108 ° -121.516743 °	6

USACE 2012 Photo #1

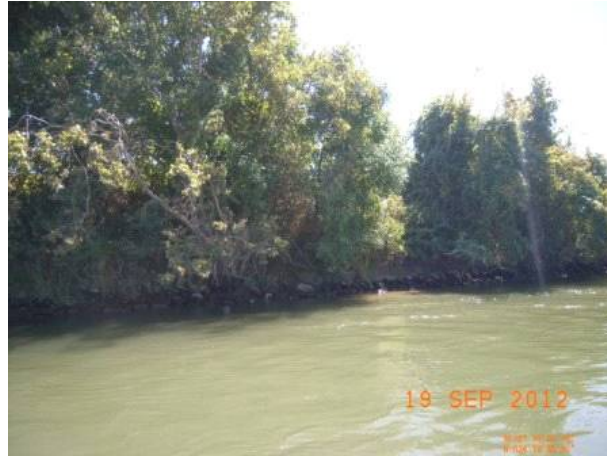
Levee Mile Report Line	7
Start Levee Mile	0.25
End Levee Mile	0.34
Location	Water Side
Category	Supplemental
Item	USACE Erosion Survey

USACE 2012 Photo #2

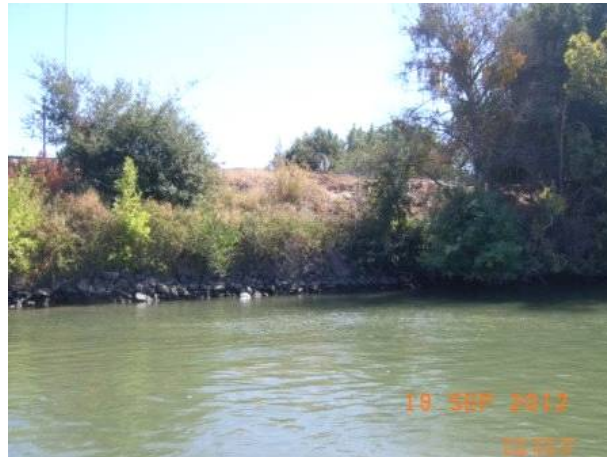
Levee Mile Report Line	7
Start Levee Mile	0.25
End Levee Mile	0.34
Location	Water Side
Category	Supplemental
Item	USACE Erosion Survey

USACE 2012 Photo #3
